RELIEF AND RECONSTRUCTION  
FUNDED WORK AT MOSUL DAM  
MOSUL, IRAQ

**SIGIR PA-07-105**  
**OCTOBER 29, 2007**

SUBJECT: Report on Relief and Reconstruction Funded Work at Mosul Dam, Iraq  
(Report Number SIGIR PA-07-105)

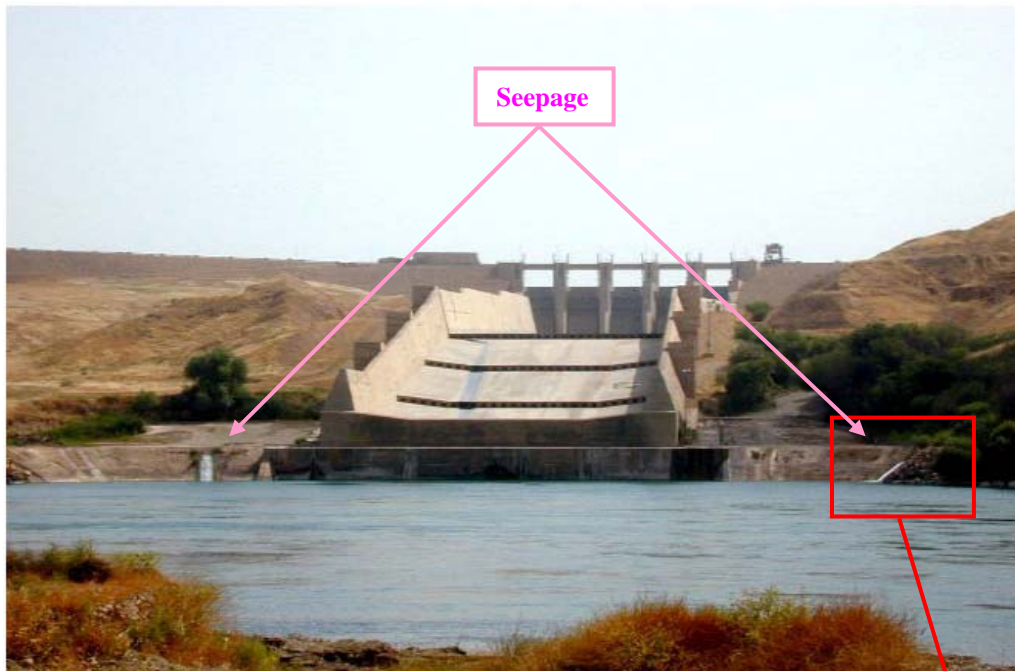
For examples of current seepages, see Site Photos 6 and 7.

**Site Photo 6. Example of seepage at the Mosul Dam**  
(Photo courtesy of USACE)

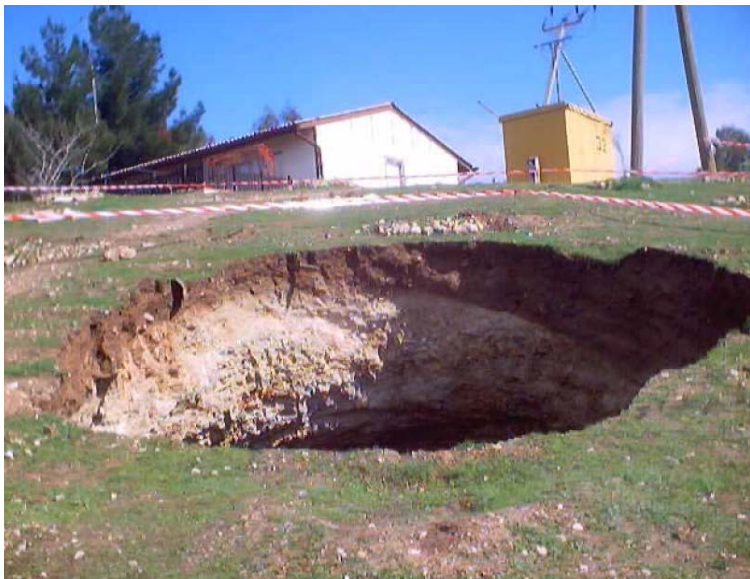
Seven sinkholes developed following initial impoundment of the reservoir. Sinkholes are an indicator of possible subsurface failure of the dam's foundation. Most sinkholes observed were downstream of the dam--with three in a linear arrangement in the work area on the right bank, approximately 500m downstream from the dam (Site Photo 8).

**Site Photo 8. Example of a sinkhole**  
(Photo courtesy of the USACE)

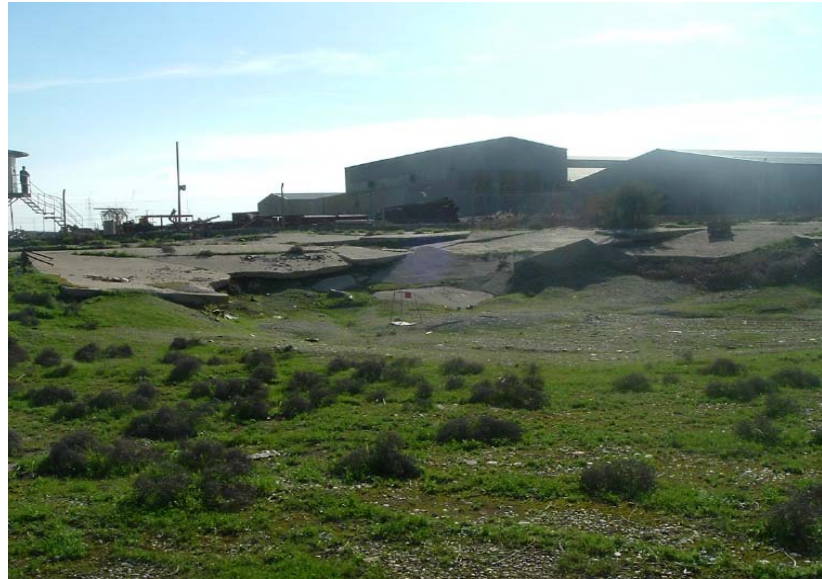
**Site Photo 9. Sinkhole beneath a concrete-paved area**  
(Photo courtesy of the USACE)

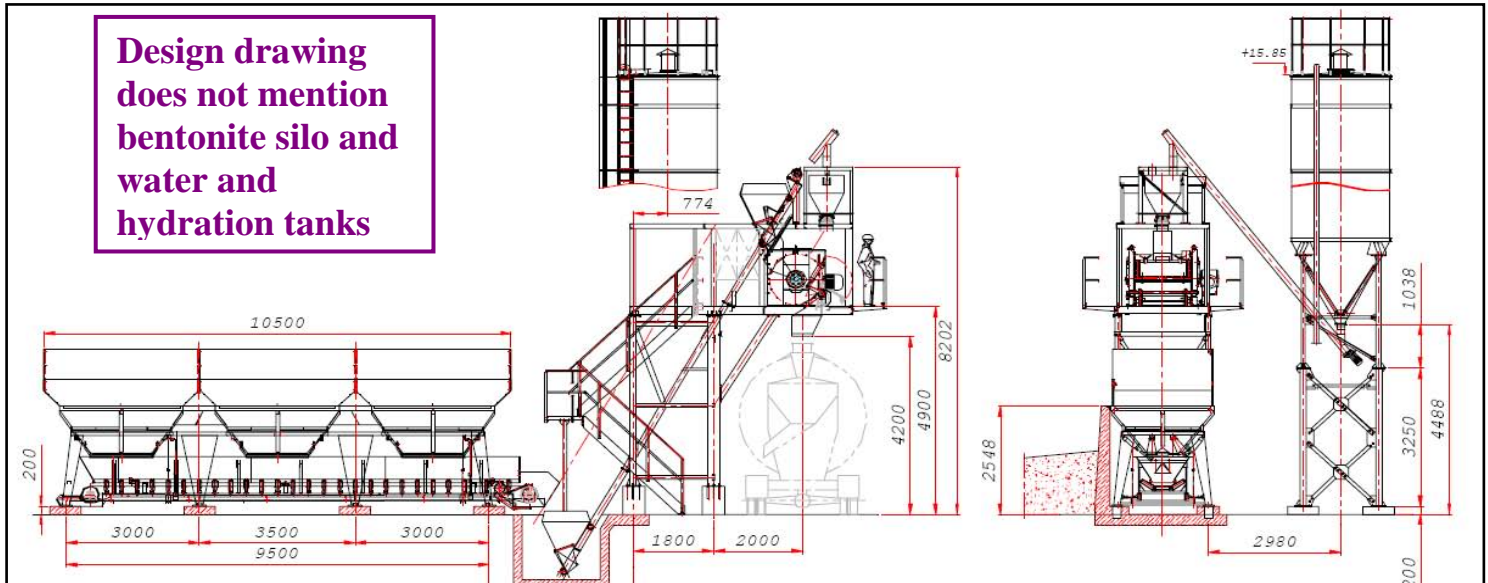
GRD provided the contractor's design submittals for the two sizes of grout-mixing plants (i.e., 30-m<sup>3</sup>/hour and 100-m<sup>3</sup>/hour), which we reviewed. For the 30-m<sup>3</sup>/hour grout-mixing plants, our review of the design drawings concluded that the contractor was clearly offering concrete-mixing plants, not grout-mixing plants (Figures 12 and 13). Grout mixing plants require a bentonite silo and water and hydration tanks, associated weighing and measuring devices, additional pumps and motors, which were not included in the design drawings.

Figure 12. Contractor's design drawing for 30-m<sup>3</sup>/hour concrete-mixing plant

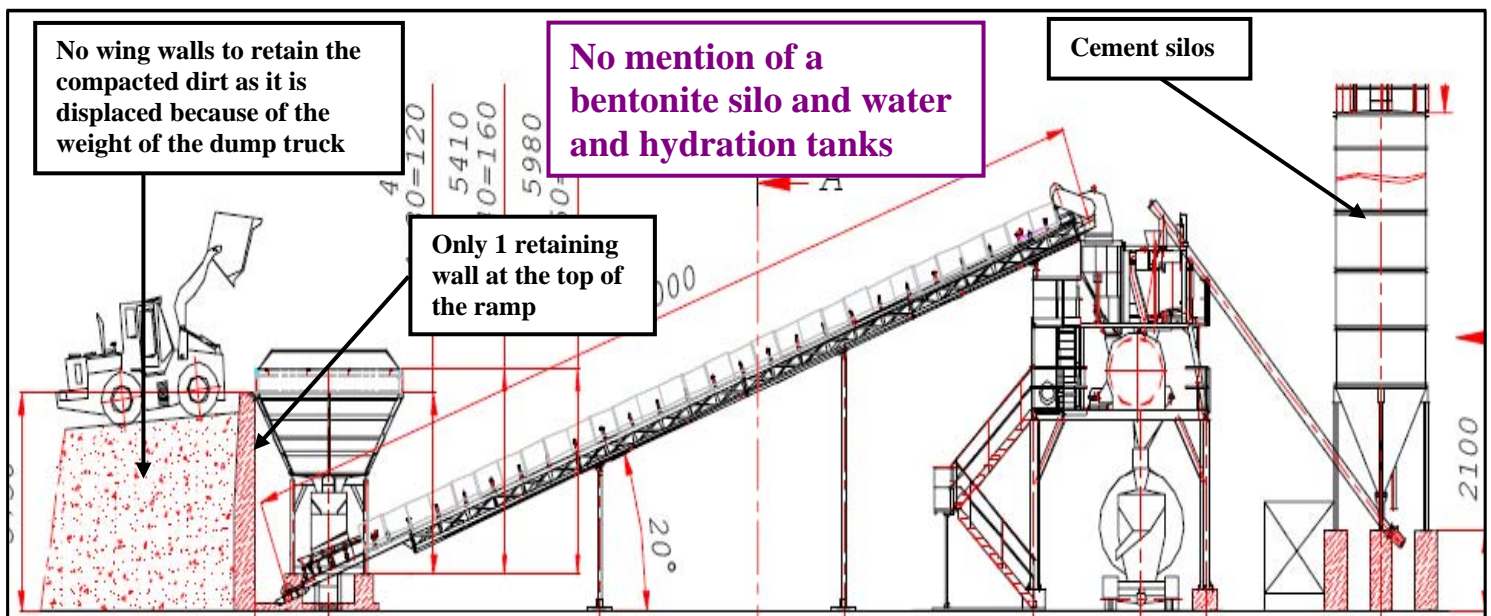
Figure 13. Contractor's design drawing for 100-m<sup>3</sup>/hour concrete-mixing plant

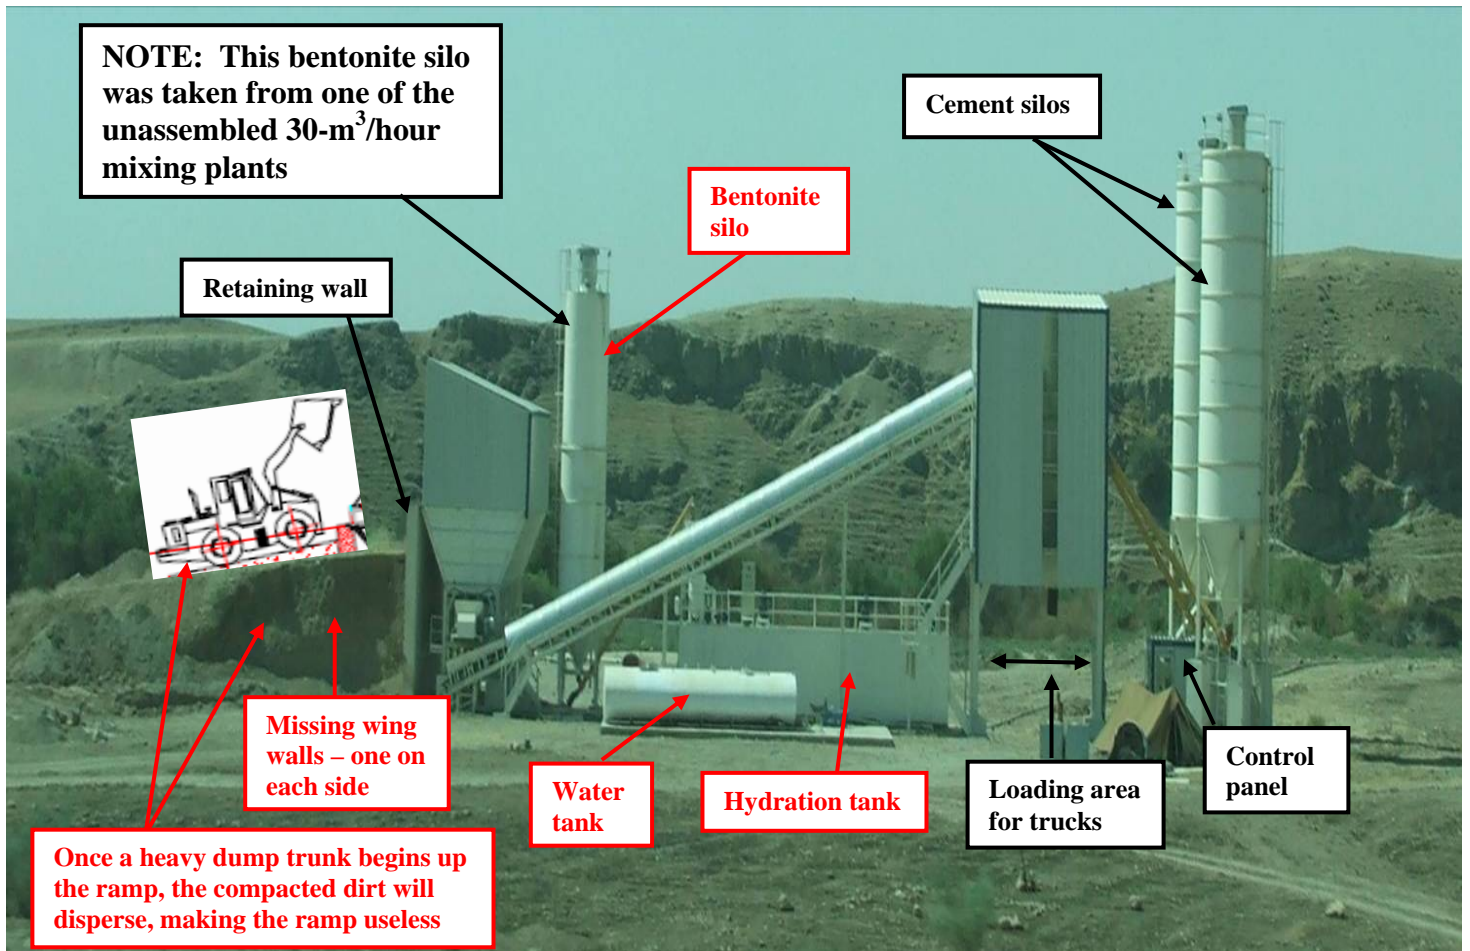
In addition, the contractor did not provide wings for the retaining walls of the 100-m<sup>3</sup>/hour modified mixing plant (Site Photo 11). Without wing walls, the ramp, where heavy dump trucks back up to drop materials into the hoppers, cannot be used. Currently, dam personnel are in the process of trying to correct this omission with their own funding.

Site Photo 11. View of the “modified” 100-m<sup>3</sup>/hour grout-mixing plant

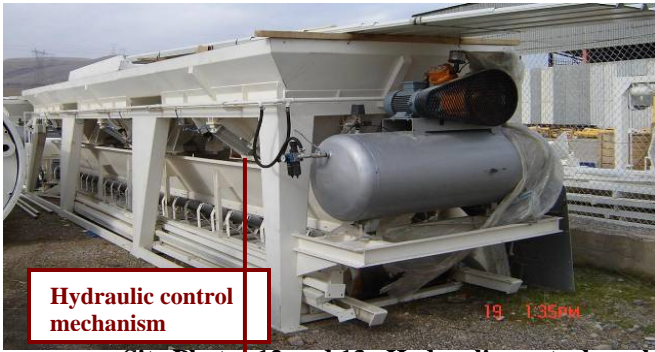
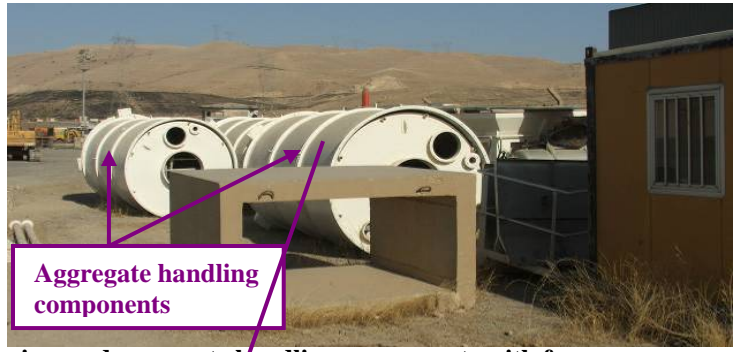
The four 30-m<sup>3</sup>/hour mixing plants are required to produce the high performance grout necessary to fully implement the proposed enhanced grouting program for the Mosul Dam. The contract required the delivery of the mixing plants by 25 July 2006. However, as a result of the EC’s failure to “notice” the contractor provided the wrong type of mixing plant, the enhanced grouting program is over one year behind schedule.

Site Photos 12 and 13. Hydraulic control mechanism and aggregate handling components with for the delivered 30-m<sup>3</sup>/hour concrete-mixing plant.

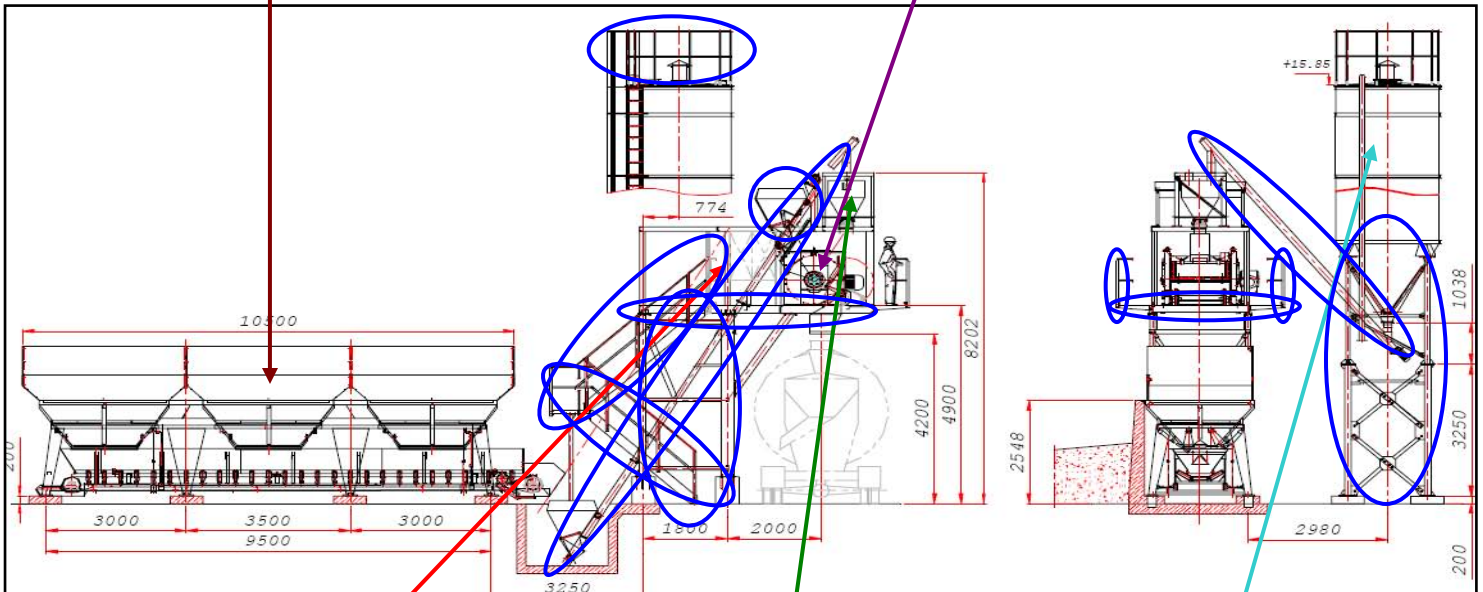
Figure 27. The contractor's design drawing for the 30-m<sup>3</sup>/hour concrete-mixing plant  
(Colored arrows identify pieces found at the site and what relationship they are to the design)  
(Areas circled in blue are equipment required by the design that could not be accounted for/located during site visit)

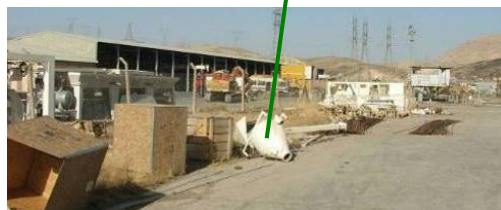
Site Photo 16. Miscellaneous 30 m<sup>3</sup>/hour concrete-mixing plant parts

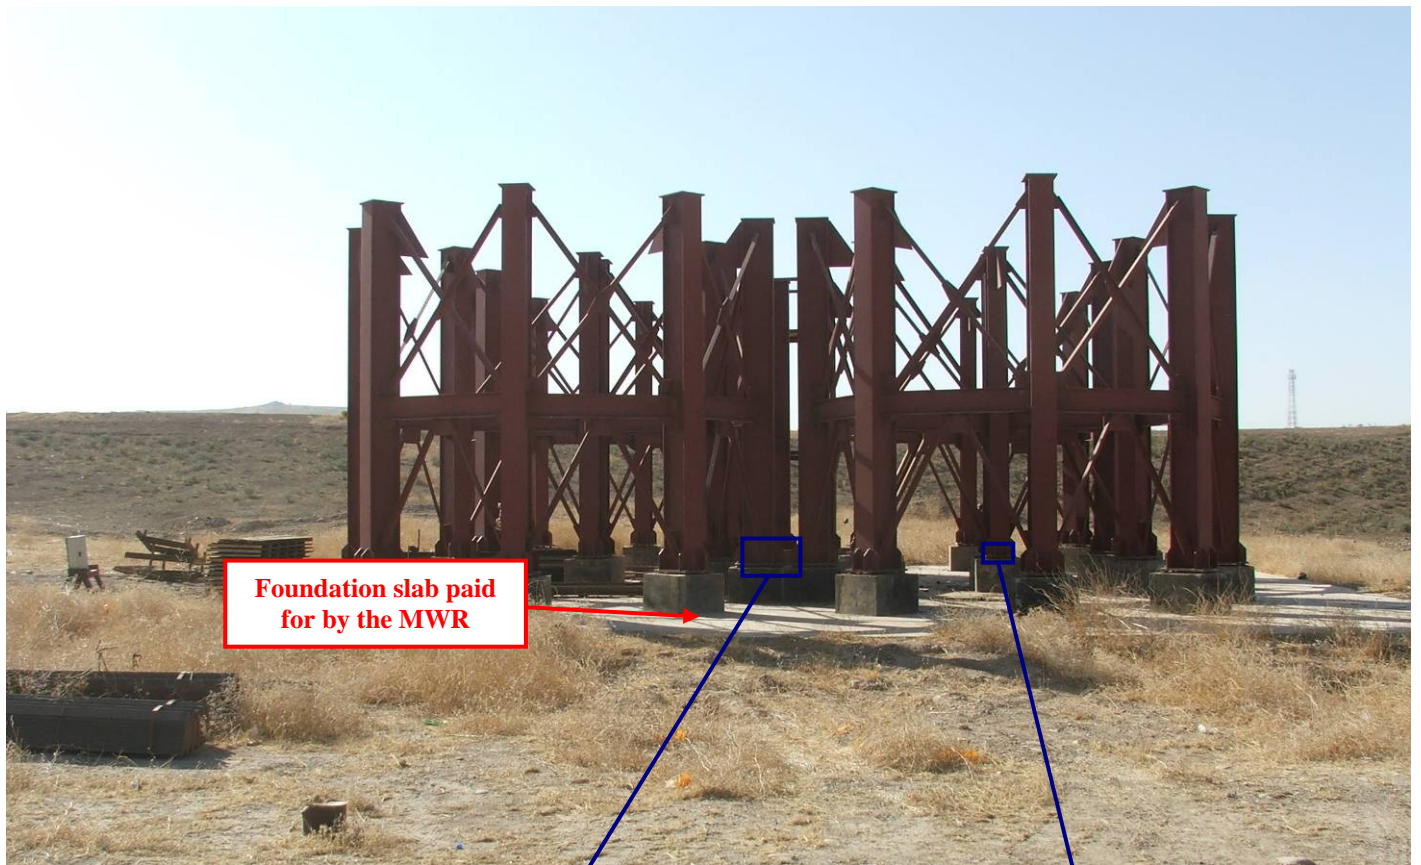
Foundation bolts are essential for the stability of the structure. The contractor erected steel columns, bracings, and beams by welding structural steel elements together. We observed foundation bolts cast within concrete columns so deficient that there was insufficient thread available to properly fasten the nuts on. (Site Photos 18 and 19). A foundation bolt is essential to secure the steel columns. Inadequately installed foundation bolts increase the probability of the structure's failure. We identified 43 of 144 (30%) foundation bolts inadequately installed. The installation of the foundation bolts also contradicts the contractor's own design construction techniques, which required bolt threads to extend higher than the nut (Figure 28 and Site Photo 20). In some instances, the contractor extended the foundation bolt well beyond the nut and continued to use poor installation practices, such as the use of too many washers (Site Photo 21). Considering that the stationary silos are to hold approximately 6,000 tons of cement, along with the weight of the steel superstructure with columns, we believe that inadequate installation of the foundation bolts leaves this structure in a potentially dangerous condition.

**Site Photo 17. View of the partially constructed stationary silos**

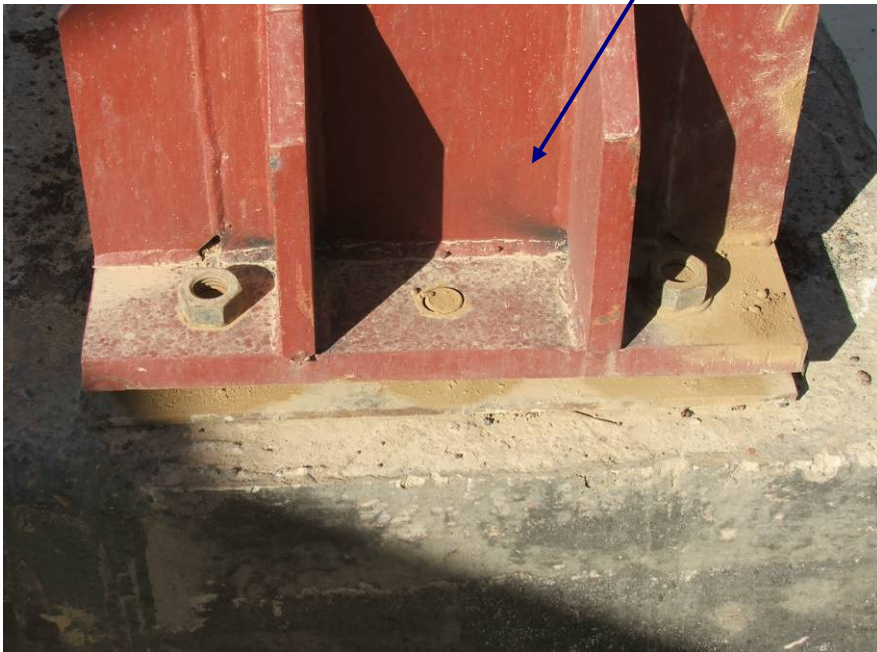
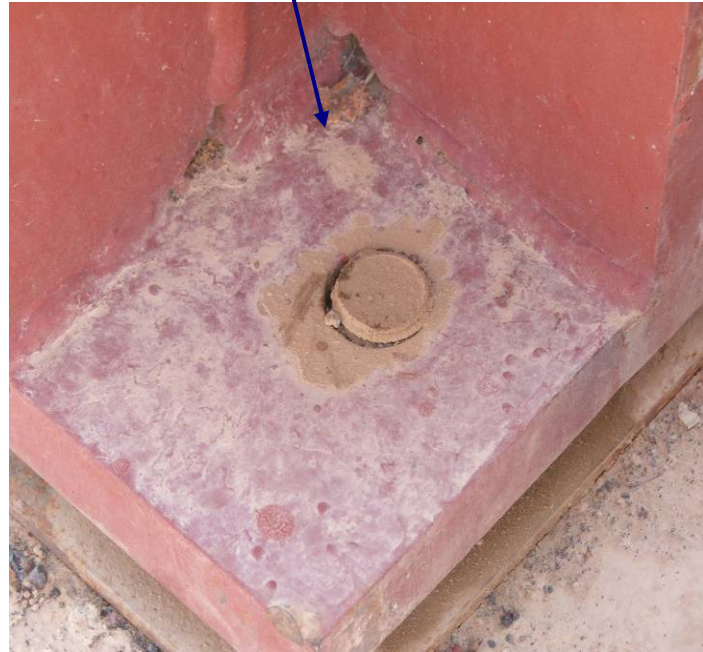
We identified an instance where construction did not appear to be adequate. The inspection team observed that some foundation bolts cast within concrete columns had insufficient thread to properly fasten the nuts. Specifically, we determined that 43 of the 144 (30%) foundation bolts were inadequately installed. Further, the installation of the foundation bolts also contradicted the contractor's own design construction techniques, which required bolt threads to extend higher than the nut. Complete design drawings are needed to determine if the remaining foundation bolts are adequately secured within the foundation or pose a serious threat of failure. Because each stationary silo will hold approximately 1,500 tons of cement, we believe that the inadequate installation of the foundation bolts leaves this structure in a potentially dangerous condition.

**Site Photos 18 and 19. Close-up view of foundation bolts for the stationary silos**

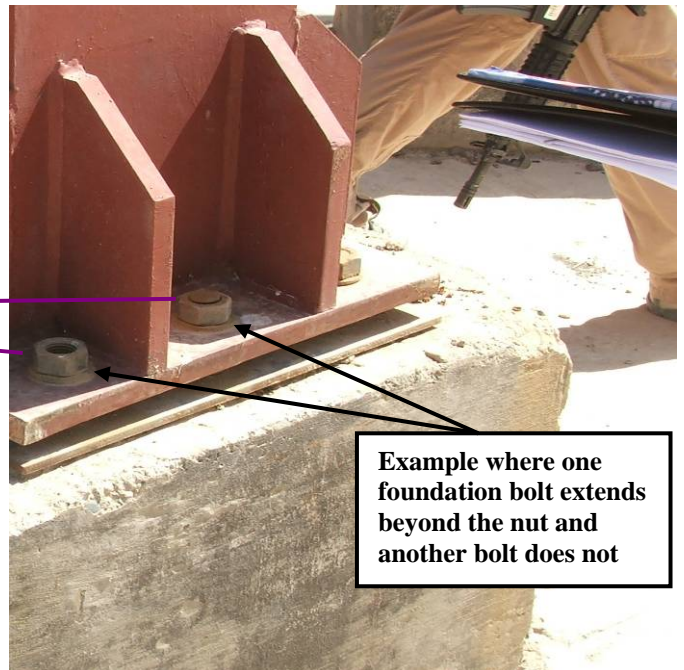
**Site Photo 20. Examples of installation practices**

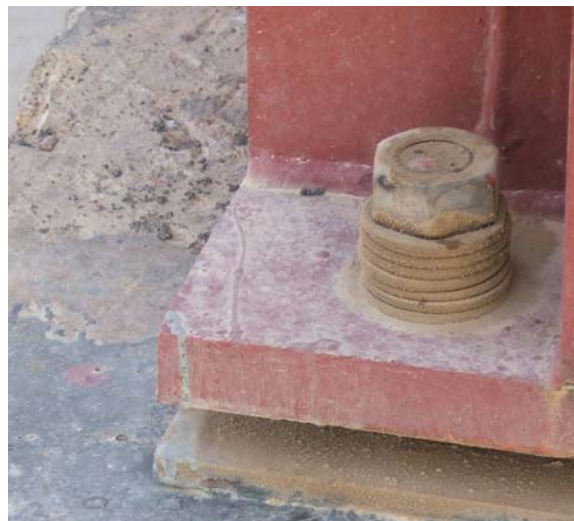
**Site Photo 21. Poor installation technique (the use of 7 washers)**

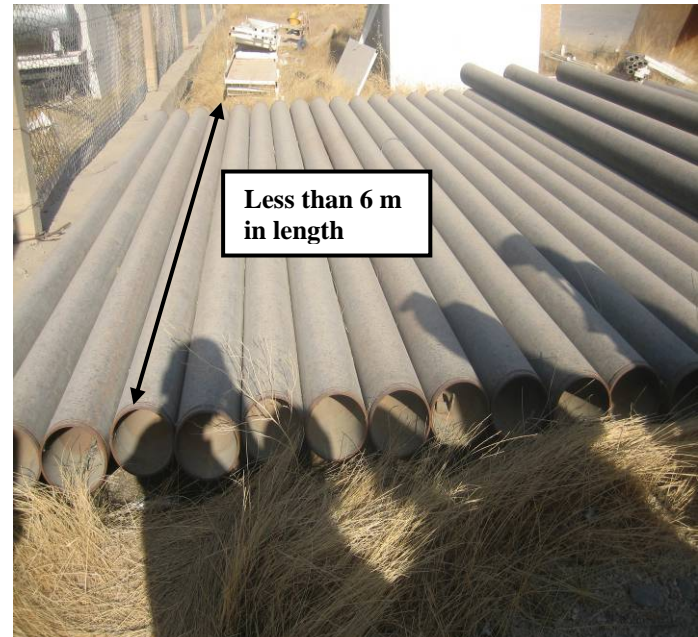
Mosul Dam personnel stated that because the pipe sizes are not accurate, workers will have to cut and weld two pieces together (which is very difficult to do) or simply not use the pieces. Currently, the pipes sit unused located outside a warehouse.

Site Photo 26. Pipes delivered by the contractor

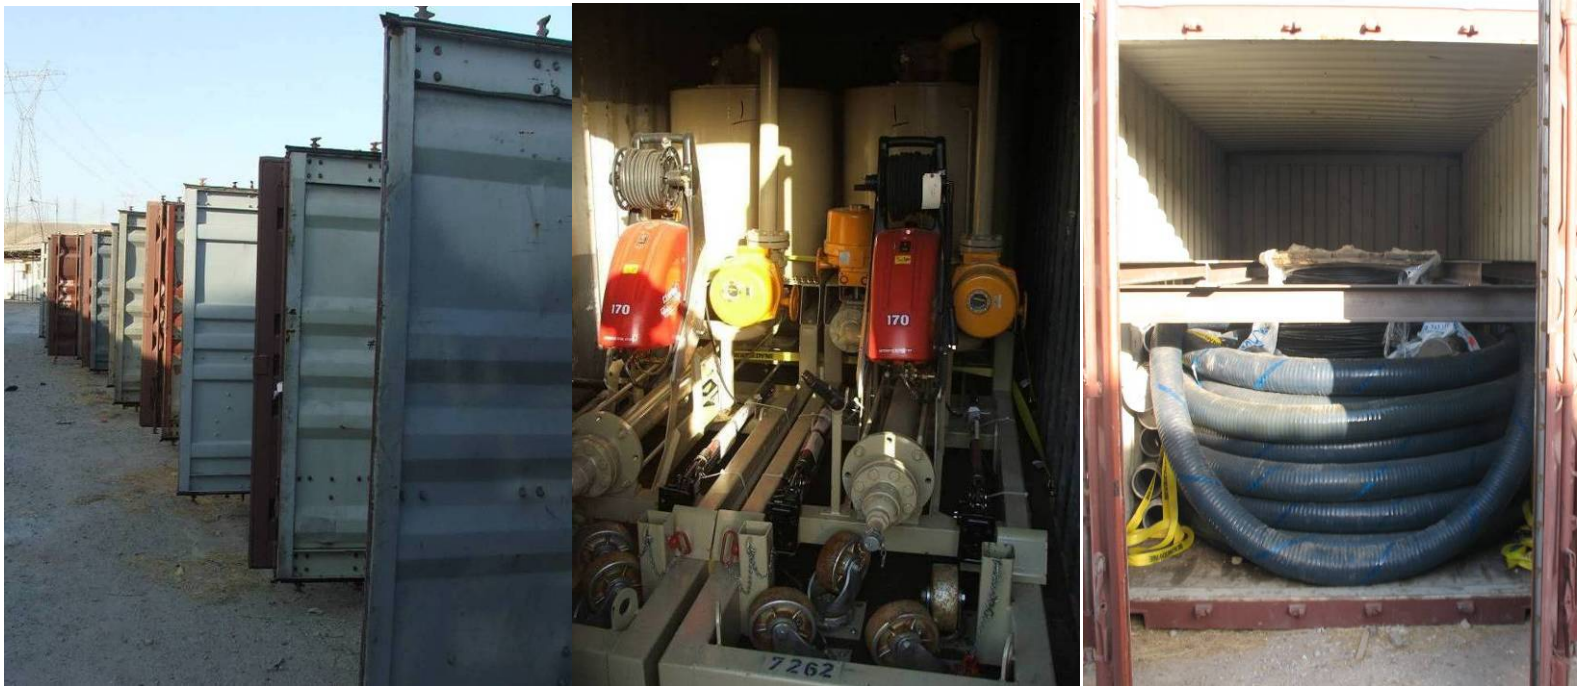
**Site Photos 30, 31, and 32. Conex boxes with partially assembled enhanced grouting equipment**

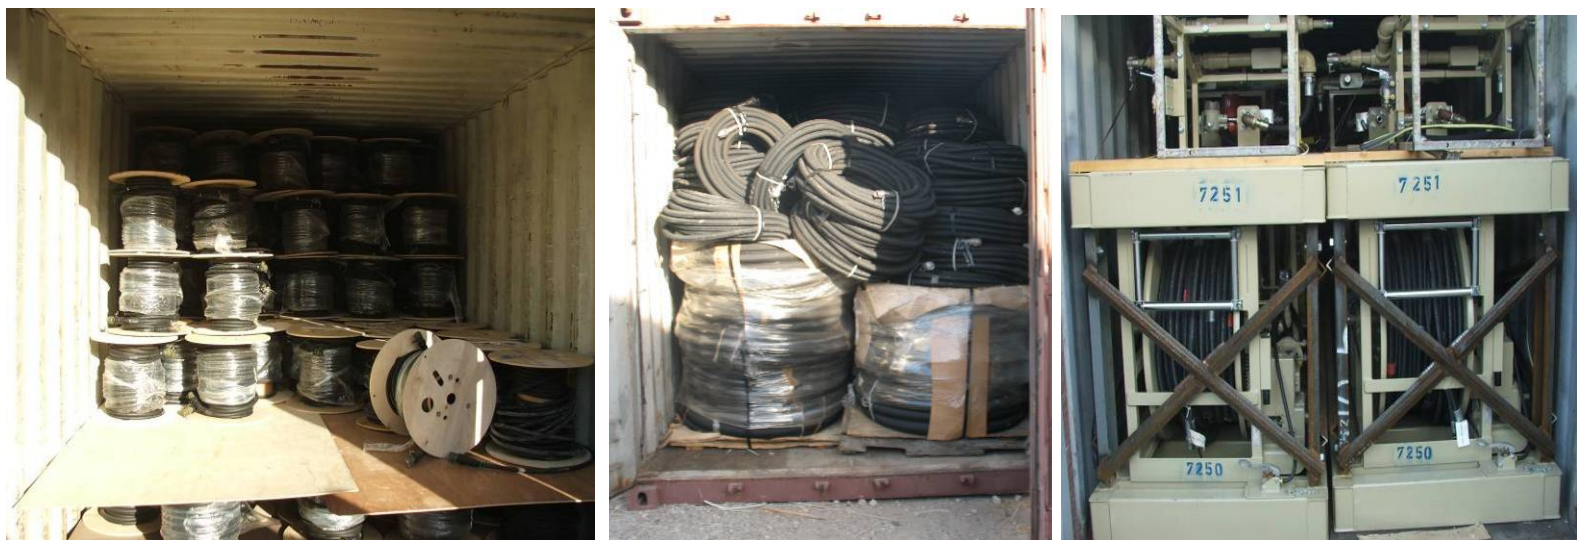
**Site Photos 33, 34, and 35. Conex boxes with partially assembled enhanced grouting equipment**

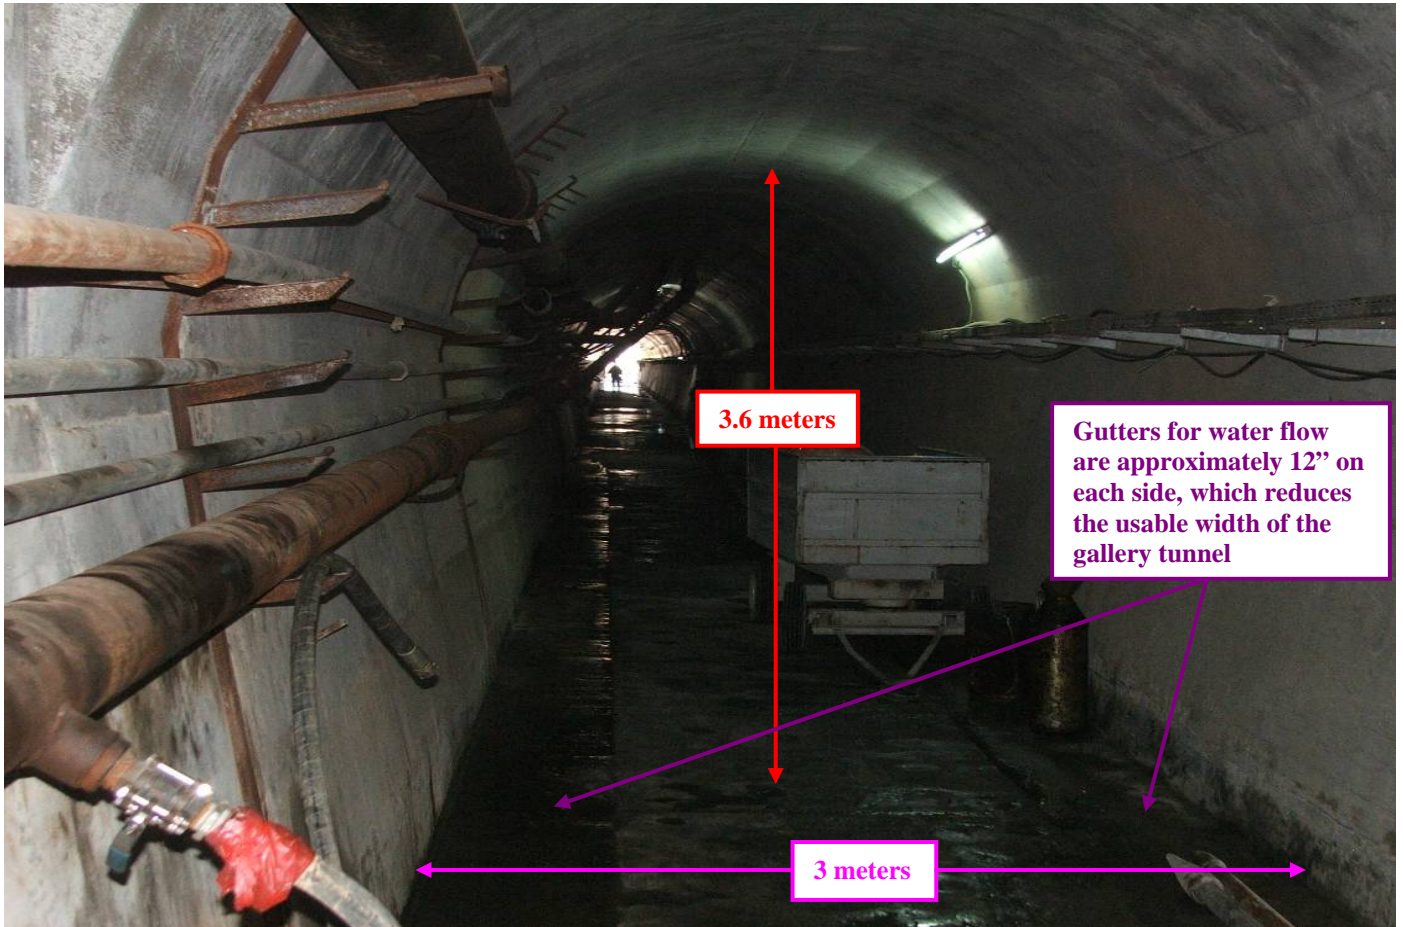
We later spoke with the dam manager, who stated that this equipment is not appropriate for the Mosul Dam. The gallery is very small and tight, with dimensions of 3 m wide by 3.6 m high (Site Photo 36) and there are sharp turns and steep inclines throughout the length of the 3.4 km gallery (Site Photo 37). In the manager’s opinion, the equipment is too large and heavy to be used within the Mosul Dam gallery. Since the equipment was not completely assembled at the time of our site visit, the only visuals of the assembled equipment available are photographs taken during its commissioning in Harrisburg, PA (Site Photos 38-40). While Site Photo 40 shows the two pieces of equipment at 90 degrees, according to the USACE’s grouting expert, the “two units would be in-line with each other.” In the dam manager’s opinion, which is based upon more than 20 years of experience at the Mosul Dam, the equipment procured was too wide and long to fit inside the gallery. Until the equipment is completely assembled, operational, and schematics provided for its use; it will not be known whether the equipment will fit in the gallery or not.

Site Photo 36. View of the dimensions within the Mosul Dam gallery tunnel

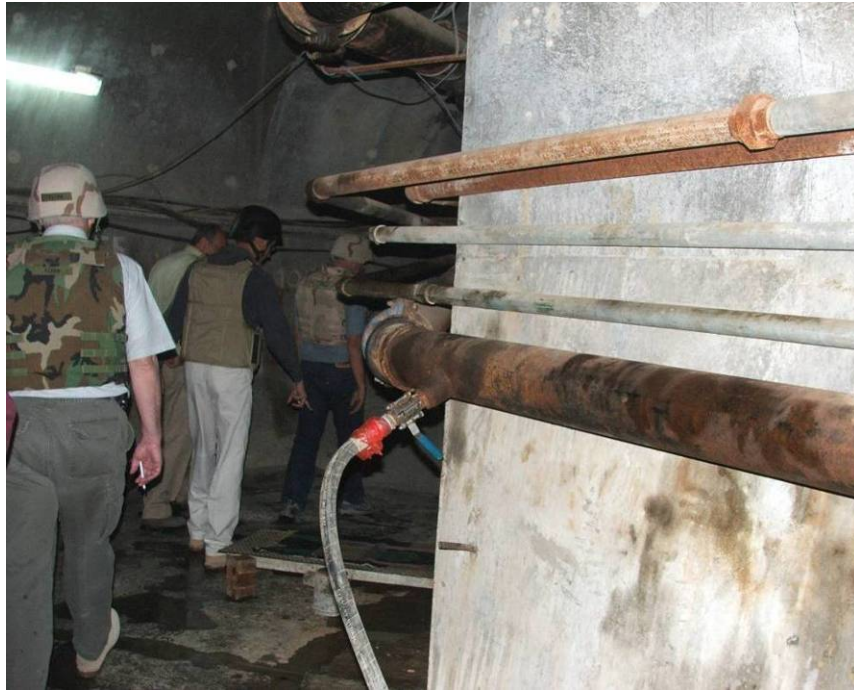
Site Photo 37. Partial view of the sharp right turn within the gallery tunnel
